## Identification and Mitigation of Machining Process Failures in XE 611 SZK Crankshaft through an Integrated FMEA and Pareto Analysis Approach

Ichlas Nur<sup>1</sup>, Rifki Abdul Dhohir<sup>2</sup>, Nasirwan<sup>3</sup>, Nusyirwan<sup>4</sup>, Yuli Yetri<sup>5\*</sup>  
<sup>1,2,3,4</sup>Mechanical Engineering Department, Politeknik Negeri Padang  
email: yuliyetri@pnp.ac.id

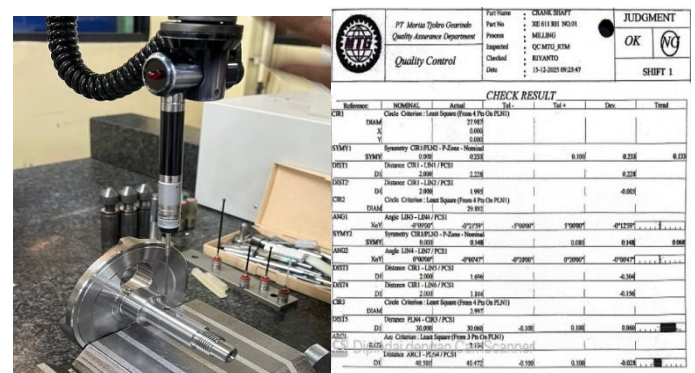
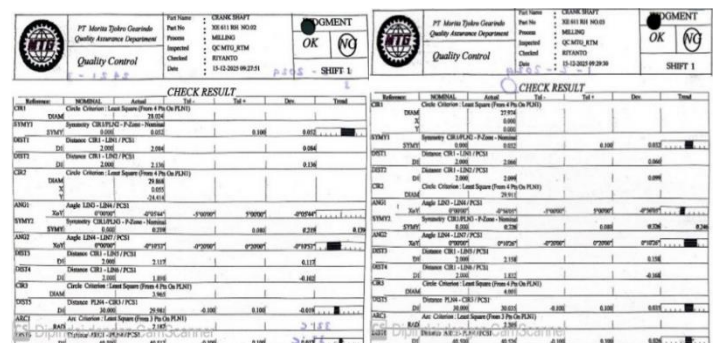
Based on the NG data collected from the machining process during the May–November period, an increasing trend of Not Good (NG) products was identified, particularly in the milling and drilling processes. Most of the NG cases showed a consistent pattern of deviation. Furthermore, based on crankshaft inspections using a Coordinate Measuring Machine (CMM), the results from three CMM reports (No.01, No.02, and No.03) indicated that several symmetry parameters exceeded the specified tolerance limits, as shown in Figure 5.

Based on Figure 5, the CMM inspection results indicate the presence of asymmetry defects. These asymmetry deviations generally occurred in the parameters **Symmetry CIR1/PLN2 – P-Zone** (milling) and **Symmetry CIR1/PLN3 – P-Zone** (drilling). This asymmetry indicates that the geometric positions of the milling and drilling features were not precisely centered or properly aligned with the reference datum specified in the engineering drawing. As a result, the material removal process occurred under conditions where the workpiece was not perfectly centered during machining operations [10]. Based on the results of the physical inspection of the jig and re-measurement using a bore gauge, the diameter of the jig bushing/locator, which determines the crankshaft position, can be observed as shown in Figure 6.

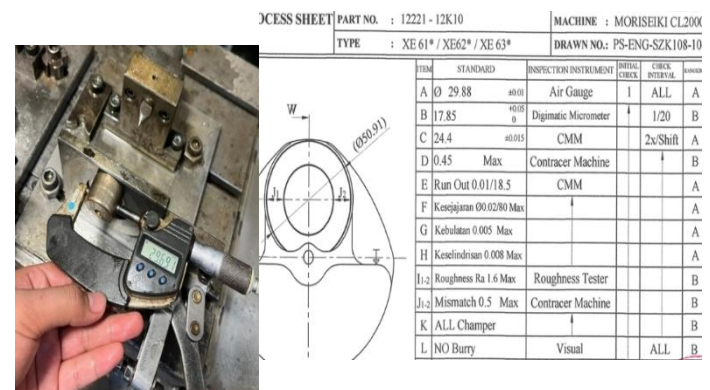
Figure 7. Measurement of the Locator Jig

identified as the main cause of positional deviations during the milling and drilling processes. The inspection results of the locator jig condition are presented in Figure 7. The measurement results showed that the locator jig diameter was 29.691 mm, whereas the specification in the process sheet was  $\text{Ø}29.880 \pm 0.1$ . This indicates that the locator jig was in an undersize condition (-0.189 mm). Consequently, the locator jig was unable to hold the crankshaft properly during machining operations. This condition triggered positional shifts, resulting in NG products. Furthermore, the roughness inspection conducted to ensure that the surface quality of the crankshaft after the grinding machining process met the required standards is shown in Figure 8.

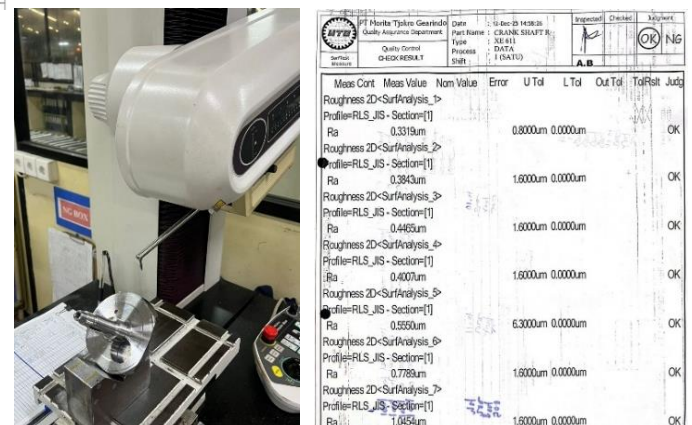
Figure 8. Roughness Inspection Results

All measured Ra values remained below the maximum tolerance limit, indicating that no values exceeded the upper tolerance and no out-of-tolerance conditions occurred. These results demonstrate variations in surface roughness among the measurement points, which are still considered acceptable due to differences in measurement positions and the machining/grinding tool process conditions [11].
