AN INVESTIGATION OF FREQUENCY SPECTRUM ANALYSIS FOR THE DETECTION OF BEARING DAMAGE IN CENTRIFUGAL PUMP UNIT 731PU1205 F2

This study explores the use of frequency spectrum analysis to identify bearing faults in centrifugal pumps, specifically focusing on the 731PU1205 F2 unit at PT Sari Dumai Oleo (SDS2). Vibration data were collected using the SKF CMDT 391 device, concentrating on velocity and enveloped acceleration spectra from two measurement positions (3V and 3H). The analysis examined characteristic bearing frequencies, including Ball Pass Frequency Outer (BPFO), Ball Pass Frequency Inner (BPFI), Ball Spin Frequency, and Fundamental Train Frequency, to detect defects related to the outer race, inner race, rolling element, or cage. The results revealed vibration spectra with frequency peaks corresponding to BPFO and BPFI, indicating early-stage wear in the bearing components. These findings demonstrate that frequency spectrum analysis serves as an effective predictive maintenance tool for the early detection of bearing faults, which has the potential to reduce both downtime and maintenance costs in industrial pump operations.

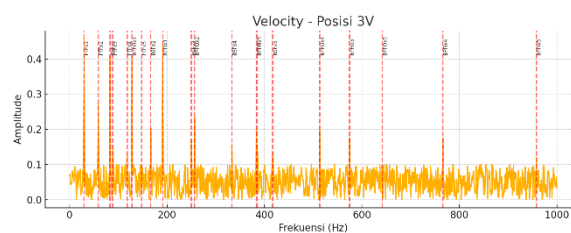
Figure 6. 3V Position Spectrum Velocity Overlay

Based on the vibration analysis at the vertical position (3V) of the centrifugal pump, the velocity spectrum shows a peak vibration of around 295 Hz, which is close to the frequency of BPFO (175.8 Hz) and its harmonics. This indicates the potential for damage to the outer race bearing. The enveloped acceleration spectrum in this position shows a fairly high value of 11.91 gE, with many harmonic peaks between 50–300 Hz, including around 60.5 Hz which is close to the BSF value, which is the frequency of the rotation of the ball. This corroborates the indication of damage to the ball bearing. The analysis of the roughness on the 6305 C3 bearing can be seen in the overlay image of the velocity spectrum and the vertical position (3V) in Figures 6 and 7. The red dotted line indicates the harmonics of the characteristic frequency of the bearing (BPFO, BPFI, BSF, FTF).

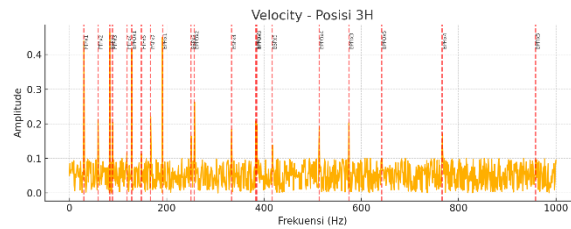
Figure 8. 3H position velocity overlay

In the horizontal position (3H), the vibration speed was 2.18 mm/s. The frequency spectrum displayed a peak in the 268–270 Hz range, which corresponds with the BPFI frequency. It suggests the potential presence of damage to the inner race bearing. Furthermore, the enveloped acceleration value was notably high at 10.51 gE, with the dominant impulsive signal occurring at approximately 60–70 Hz. This pattern reinforces the suspicion of damage to the ball element or light spalling on the bearing surface. The roughness analysis on the 6305 C3 bearing can be observed in the vertical position spectrum overlay images (3V) presented in Figures 8 and 9. The red dotted line highlights the harmonics of the characteristic frequencies of the bearing (BPFO, BPFI, BSF, FTF).

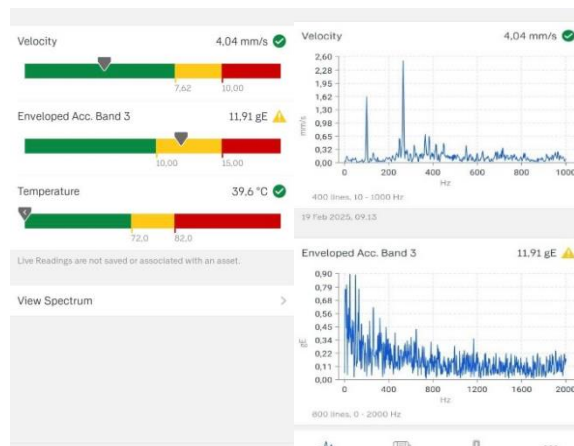
Figure 10. The Spectral Data of the position of 3V

Based on the results from the overall vibration spectrum analysis, several indications of damage to the centrifugal pump bearing have been identified, as outlined below: In the vertical position (3V), the vibration spectrum reveals a predominance of frequency components associated with the Ball Pass Frequency of the Outer Race (BPFO) and the Ball Spin Frequency (BSF). These peaks in the spectrum suggest potential damage to both the outer race and the bearing ball elements. Figure 10 illustrates the measurement data for the 3V position. Conversely, in the horizontal position (3H), the vibration spectrum is primarily characterised by a frequency component corresponding to the Ball Pass Frequency of the Inner Race (BPFI) and a consistent presence of BSF. The prominence of the BPFI frequency indicates suspected damage to the inner race bearing, while the recurring BSF frequency further supports the indication of degradation in the ball element. Additionally, the recorded enveloped acceleration values, which exceed the general threshold of 10 gE in both positions, suggest that the damage is at an intermediate to advanced stage. Therefore, it is recommended to promptly undertake maintenance actions or replace bearing components to prevent a complete system failure. Figure 10 shows the measurement data for the 3H position.

The spectral data presented in Figure 10 for the position of 3V (vertical) demonstrate measurement results indicating a vibration velocity of 4.04 mm/s and an amplified acceleration of 11.91 gE. These values reflect the system's dynamic behavior under analysis, providing critical insights into its performance characteristics
