AN INVESTIGATION OF FREQUENCY SPECTRUM ANALYSIS FOR THE DETECTION OF BEARING DAMAGE IN CENTRIFUGAL PUMP UNIT 731PU1205 F2

This study explores the use of frequency spectrum analysis to identify bearing faults in centrifugal pumps, specifically focusing on the 731PU1205 F2 unit at PT Sari Dumai Oleo (SDS2). Vibration data were collected using the SKF CMDT 391 device, concentrating on velocity and enveloped acceleration spectra from two measurement positions (3V and 3H). The analysis examined characteristic bearing frequencies, including Ball Pass Frequency Outer (BPFO), Ball Pass Frequency Inner (BPFI), Ball Spin Frequency, and Fundamental Train Frequency, to detect defects related to the outer race, inner race, rolling element, or cage. The results revealed vibration spectra with frequency peaks corresponding to BPFO and BPFI, indicating early-stage wear in the bearing components. These findings demonstrate that frequency spectrum analysis serves as an effective predictive maintenance tool for the early detection of bearing faults, which has the potential to reduce both downtime and maintenance costs in industrial pump operations.

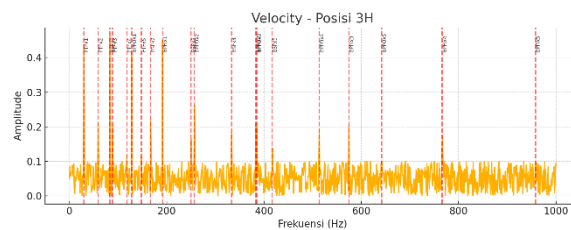
Figure 8. 3H position velocity overlay

In the horizontal position (3H), the vibration speed was 2.18 mm/s. The frequency spectrum displayed a peak in the 268–270 Hz range, which corresponds with the BPFI frequency. It suggests the potential presence of damage to the inner race bearing. Furthermore, the enveloped acceleration value was notably high at 10.51 gE, with the dominant impulsive signal occurring at approximately 60–70 Hz. This pattern reinforces the suspicion of damage to the ball element or light spalling on the bearing surface. The roughness analysis on the 6305 C3 bearing can be observed in the vertical position spectrum overlay images (3V) presented in Figures 8 and 9. The red dotted line highlights the harmonics of the characteristic frequencies of the bearing (BPFO, BPFI, BSF, FTF).

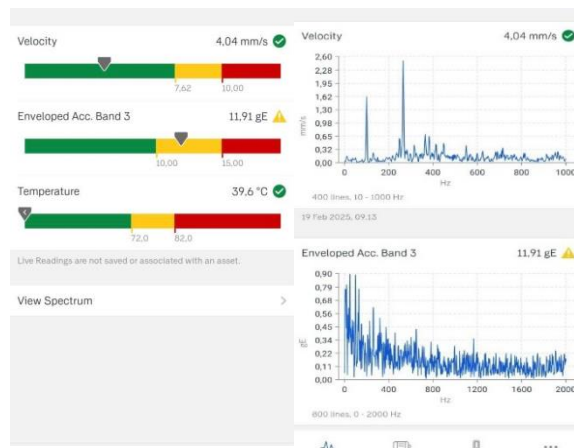
Figure 10. The Spectral Data of the position of 3V

Based on the results from the overall vibration spectrum analysis, several indications of damage to the centrifugal pump bearing have been identified, as outlined below: In the vertical position (3V), the vibration spectrum reveals a predominance of frequency components associated with the Ball Pass Frequency of the Outer Race (BPFO) and the Ball Spin Frequency (BSF). These peaks in the spectrum suggest potential damage to both the outer race and the bearing ball elements. Figure 10 illustrates the measurement data for the 3V position. Conversely, in the horizontal position (3H), the vibration spectrum is primarily characterised by a frequency component corresponding to the Ball Pass Frequency of the Inner Race (BPFI) and a consistent presence of BSF. The prominence of the BPFI frequency indicates suspected damage to the inner race bearing, while the recurring BSF frequency further supports the indication of degradation in the ball element. Additionally, the recorded enveloped acceleration values, which exceed the general threshold of 10 gE in both positions, suggest that the damage is at an intermediate to advanced stage. Therefore, it is recommended to promptly undertake maintenance actions or replace bearing components to prevent a complete system failure. Figure 10 shows the measurement data for the 3H position.

The spectral data presented in Figure 10 for the position of 3V (vertical) demonstrate measurement results indicating a vibration velocity of 4.04 mm/s and an amplified acceleration of 11.91 gE. These values reflect the system's dynamic behavior under analysis, providing critical insights into its performance characteristics

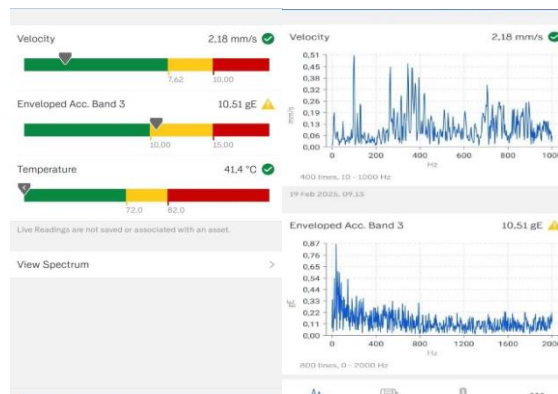
Figure 11. The Spectrum Data for 3H position

- 1) The frequency spectrum analysis successfully identified indications of bearing damage. The presence of characteristic bearing frequencies, such as the Ball Pass Frequency of the Outer Race (BPFO), Ball Pass Frequency of the Inner Race (BPFI), and Ball Spin Frequency (BSF), suggests potential damage to various bearing components.
- 2) In the vertical position (3V), a dominant frequency indicative of damage to the outer race and the ball bearing element was identified. This observation is further supported by a significantly high enveloped acceleration value of 11.91 gE.
- 3) Conversely, in the horizontal position (3H), the vibration spectrum indicates a tendency towards damage to the inner race and the associated frequency relating to the spherical element. The enveloped acceleration value of 10.51 gE reinforces the suggestion of structural damage in this area.

- 4) The vibration amplitude values recorded at both measurement points exceeded the acceptable thresholds, indicating considerable degradation of the bearing condition. Without prompt corrective action, there is a risk of system failure.
- 5) Overall, the frequency spectrum analysis method—especially via the enveloped acceleration approach—has effectively detected early signs of bearing damage. This method can successfully identify impulsive signals generated by microdefects, particularly through applying SKF Quickcollect, as illustrated in Figures 10 and 1. Consequently, this approach can be relied upon to assist technicians in making timely and informed decisions.
