## Identification and Mitigation of Machining Process Failures in XE 611 SZK Crankshaft through an Integrated FMEA and Pareto Analysis Approach

Ichlas Nur<sup>1</sup>, Rifki Abdul Dhohir<sup>2</sup>, Nasirwan<sup>3</sup>, Nusyirwan<sup>4</sup>, Yuli Yetri<sup>5\*</sup>  
<sup>1,2,3,4</sup>Mechanical Engineering Department, Politeknik Negeri Padang  
email: yuliyetri@pnp.ac.id

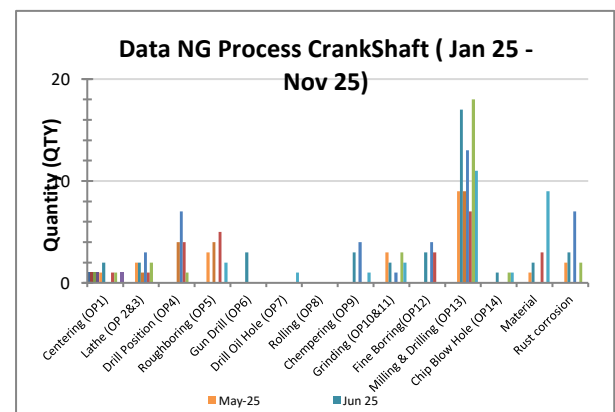
Figure 2. Bar Chart of NG Data in the Crankshaft Process

Based on the bar chart analysis, defects in the crankshaft manufacturing process were predominantly associated with **dimensional defects and circular run-out**, with a significant increasing trend observed during the **October–November**

**period.** This pattern indicates a strong possibility of process instability related to special cause variation, such as tooling wear, machine misalignment, and degradation in production system performance [3,7,8].

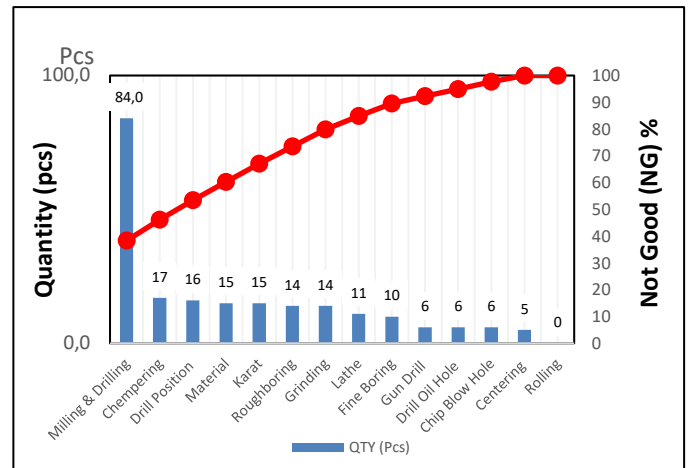
Figure 3. Pareto Diagram of Crankshaft NG Data

The Pareto diagram shown in Figure 3 presents the distribution of defect types (NG) in the crankshaft manufacturing process during the period of May 25 to November 25. The data are illustrated using bar charts representing the quantity of defects (QTY pcs) and a cumulative percentage curve (% cumulative). The purpose of this analysis is to identify the major sources of NG defects so that improvement efforts can be focused on the most significant causes. By understanding the NG distribution pattern presented in the diagram, corrective actions can be implemented more effectively, systematically, and accurately targeted. The Pareto chart indicates that the majority of defects in the crankshaft process originated from several dominant causes, particularly drilling process failures and dimensional deviations. The top five defect categories contributed to most of the total defects, indicating that improvement efforts should be concentrated on these factors in order to achieve significant quality enhancement. This approach is consistent with the Pareto principle and modern quality control theories, which emphasize prioritizing the vital few rather than the trivial many [11,12].

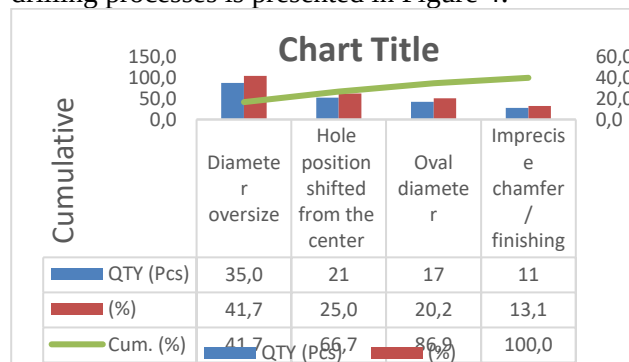
Figure 4. Types of Failures in the Milling & Drilling Process

Table 2 shows that failures in the milling and drilling processes were predominantly caused by dimensional defects and hole position deviations, which are directly related to tool condition, machining process stability, and the accuracy of the production system [8,14]. With more than 60% of the defects originating from dimensional factors, improvement strategies should be focused on process parameter control and tool management in order to achieve significant quality enhancement.

Failures in the milling and drilling processes are the result of complex interactions among human, machine, method, material, measurement, and environmental factors. Dominant factors such as tool wear, non-optimal process parameters, and system misalignment were identified as the primary causes of dimensional and geometric defects [8]. Therefore, a data-driven approach and systematic process control are essential to improve product quality and consistency [9,15].
