AN INVESTIGATION OF FREQUENCY SPECTRUM ANALYSIS FOR THE DETECTION OF BEARING DAMAGE IN CENTRIFUGAL PUMP UNIT 731PU1205 F2

This study explores the use of frequency spectrum analysis to identify bearing faults in centrifugal pumps, specifically focusing on the 731PU1205 F2 unit at PT Sari Dumai Oleo (SDS2). Vibration data were collected using the SKF CMDT 391 device, concentrating on velocity and enveloped acceleration spectra from two measurement positions (3V and 3H). The analysis examined characteristic bearing frequencies, including Ball Pass Frequency Outer (BPFO), Ball Pass Frequency Inner (BPFI), Ball Spin Frequency, and Fundamental Train Frequency, to detect defects related to the outer race, inner race, rolling element, or cage. The results revealed vibration spectra with frequency peaks corresponding to BPFO and BPFI, indicating early-stage wear in the bearing components. These findings demonstrate that frequency spectrum analysis serves as an effective predictive maintenance tool for the early detection of bearing faults, which has the potential to reduce both downtime and maintenance costs in industrial pump operations.

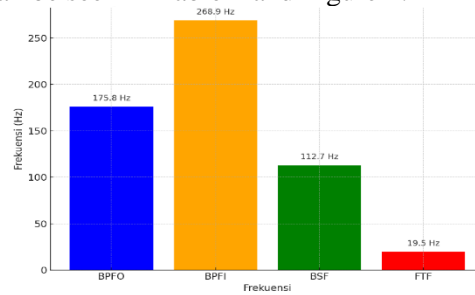
Figure 4. Results of calculation of BPFO, BPFI, BSF, and FTF formulas

results of the calculation of the frequency of bearing damage with the calculation of formulas from BPFI, BPFO, BSF, and FTF can be seen in Table 1 and Figure 4.

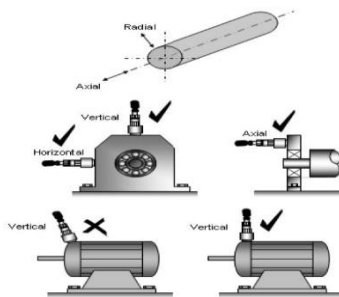
Figure 5. Spectrum Data Capture Position

Based on the vibration analysis at the vertical position (3V) of the centrifugal pump, the velocity spectrum shows a peak vibration of around 295 Hz, which is close to the frequency of BPFO (175.8 Hz) and its harmonics. This indicates the potential for damage to the outer race bearing. The enveloped acceleration spectrum in this position shows a fairly high value of 11.91 gE, with many harmonic peaks between 50–300 Hz, including around 60.5 Hz which is close to the BSF value, which is the frequency of the rotation of the ball. This corroborates the indication of damage to the ball bearing. The analysis of the roughness on the 6305 C3 bearing can be seen in the overlay image of the velocity spectrum and the vertical position (3V) in Figures 6 and 7. The red dotted line indicates the harmonics of the characteristic frequency of the bearing (BPFO, BPFI, BSF, FTF).
