AN INVESTIGATION OF FREQUENCY SPECTRUM ANALYSIS FOR THE DETECTION OF BEARING DAMAGE IN CENTRIFUGAL PUMP UNIT 731PU1205 F2

This study explores the use of frequency spectrum analysis to identify bearing faults in centrifugal pumps, specifically focusing on the 731PU1205 F2 unit at PT Sari Dumai Oleo (SDS2). Vibration data were collected using the SKF CMDT 391 device, concentrating on velocity and enveloped acceleration spectra from two measurement positions (3V and 3H). The analysis examined characteristic bearing frequencies, including Ball Pass Frequency Outer (BPFO), Ball Pass Frequency Inner (BPFI), Ball Spin Frequency, and Fundamental Train Frequency, to detect defects related to the outer race, inner race, rolling element, or cage. The results revealed vibration spectra with frequency peaks corresponding to BPFO and BPFI, indicating early-stage wear in the bearing components. These findings demonstrate that frequency spectrum analysis serves as an effective predictive maintenance tool for the early detection of bearing faults, which has the potential to reduce both downtime and maintenance costs in industrial pump operations.

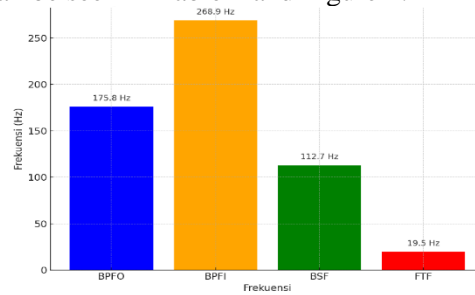
Figure 4. Results of calculation of BPFO, BPFI, BSF, and FTF formulas

results of the calculation of the frequency of bearing damage with the calculation of formulas from BPFI, BPFO, BSF, and FTF can be seen in Table 1 and Figure 4.
