Analysis of Types of Flexible Pavement Damage Using the Pavement Condition Index Method

¹Teknik Sipil, Fakultas Teknik dan Sains, Universitas Ibn Khaldun

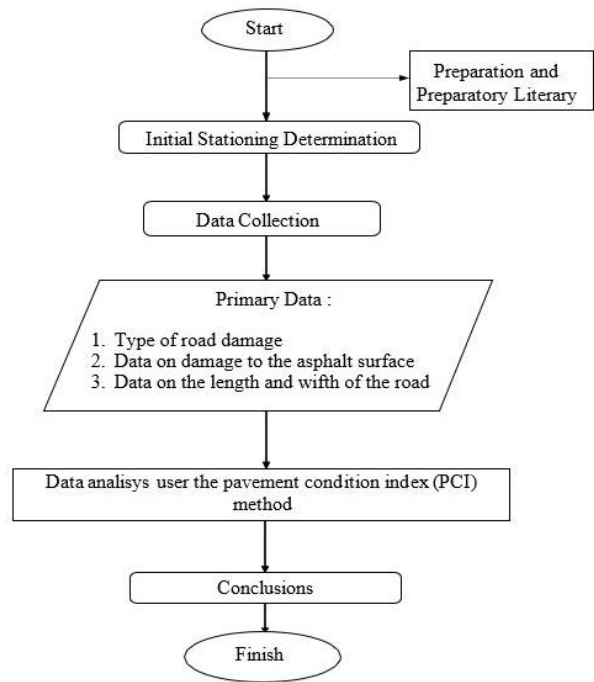
Figure 1 Research flow diagram

The research flow diagram is shown in Figure 1.
